Fukushima: Status for en igangværende ulykke

Lauritzen, Bent; Nonbøl, Erik

Bent Lauritzen og Erik Nonbøl

Risø DTU

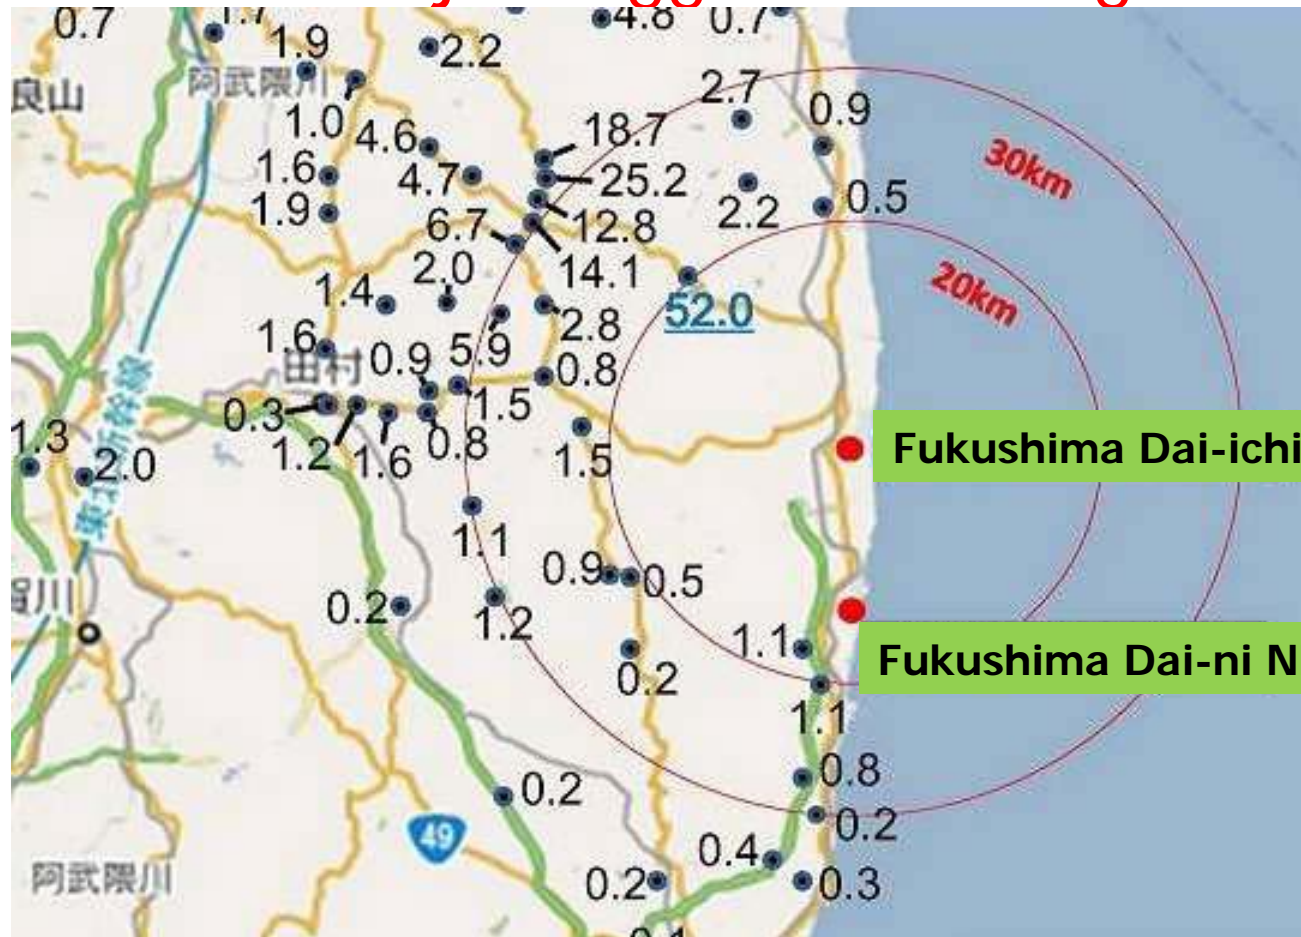
Forhøjet baggrundsstråling

μSv/hour
(April 10)

Fukushima Dai-ichi NPP

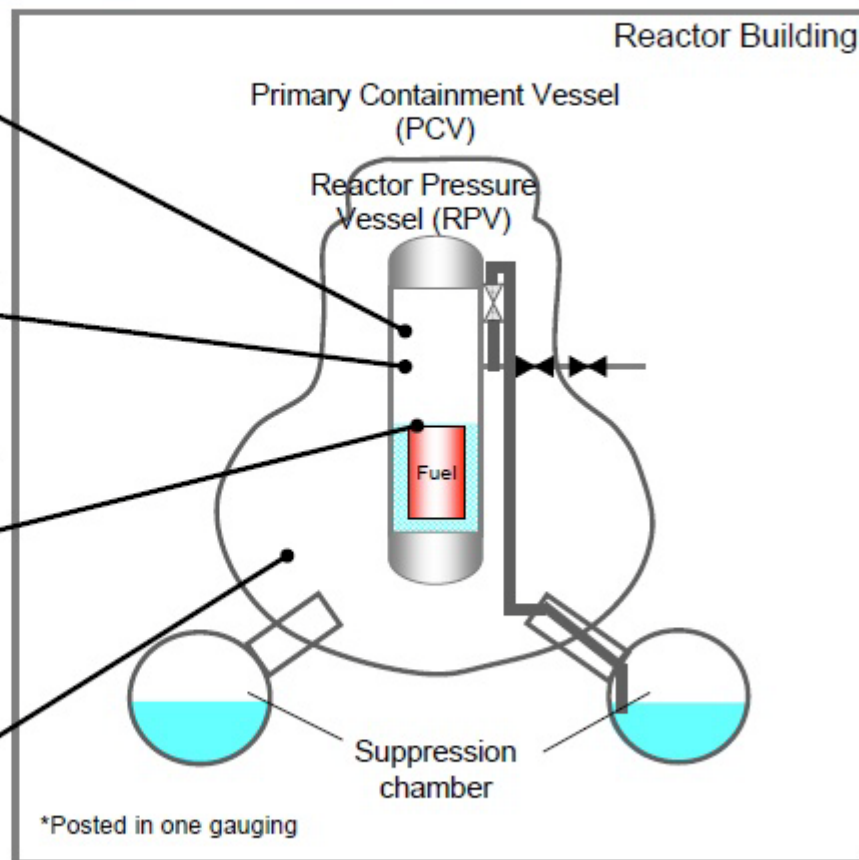
Drywell pressure [MPa-abs]

Unit 1	Unit 2	Unit 3
0.1247	0.116	0.1015

*We are judging the plant status by utilizing data obtained from multiple instruments including their changing trend in a comprehensive manner considering that some of them possibly are showing inaccurate data due to the irregular condition for use
